Even tougher in the face

Special sensor technology for special requirements

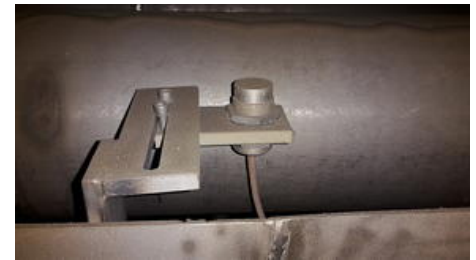
The one-way barrier consisting of the transmitter **PS180024** (top) and the receiver **PE180424** proved to be the right choice for the demanding application in the pickling line.

As the solution therefore had to be via a very precise, small measuring point with a large range and also withstand very adverse environmental conditions, an application specialist from ipf electronic recommended a laser light barrier. The through-beam sensor consisting of a transmitter **PS180024** and a receiver **PE180424** in metal housing (protection class IP67) has a large switching distance of 0 to a maximum of 60m, is suitable for ambient temperatures of up to +50° C, and can be adjusted very well due to the visible laser light in the area above the roller conveyor.

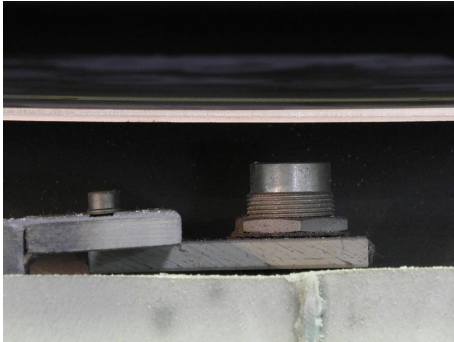
The inductive sensors have an active surface made of stainless steel and are therefore very robust (protection class IP68) and designed for ambient temperatures up to +70° C.

For this reason, the decision was made to use the inductive sensors **IO300106** from ipf electronic with an active surface made of stainless steel. These particularly robust devices are designed for ambient temperatures of up to +70° C and have protection class **IP68**. Three inductive sensors operated in parallel were installed at the input and output of the pickling chamber so that they can detect the copper plates from below. "The arrangement of the sensors was chosen deliberately, as the plate in the chamber can move slightly in the longitudinal direction. This ensures that we can inquire a larger area of the plate from the underside and that at least one sensor always responds. If the material position were only inquired in the middle, a displaced plate could also reach the area of the chamber door, which would then sometimes open a little, leading to error messages from the control (unit)," reports Schnock. If one of the inductive sensors at the chamber exit detects the underside of the plate end when a copper plate is fed into the pickling chamber, the doors close and the spraying process begins.

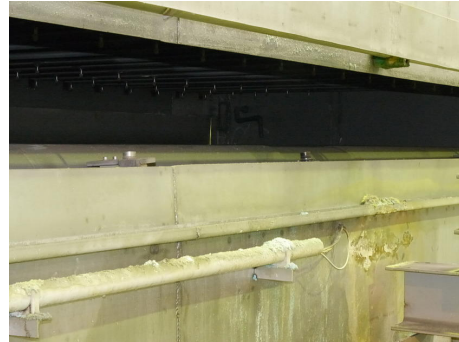
The IO300106 inductive sensors were installed in such a way that they can detect the copper plates from below.

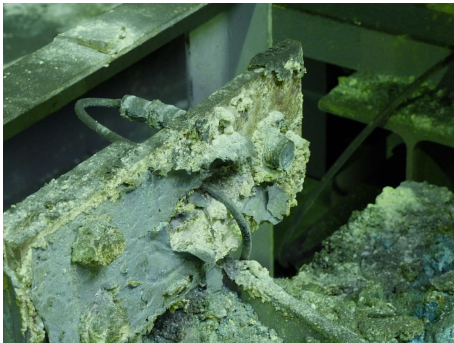
Three parallel-operated inductive sensors are positioned at the input and output of the pickling chamber. The special arrangement ensures that a larger area of the copper plate can be inquired from the underside and thus at least one sensor responds.

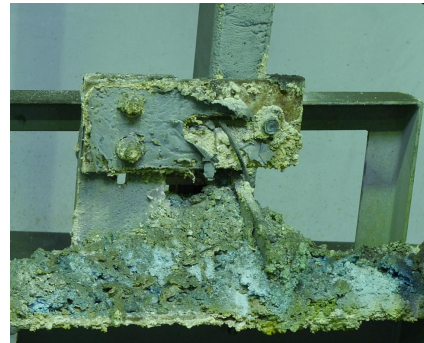
The acidic stain is extremely hard on the laser light barriers in the buffer zones, as can be clearly seen, but the sensors, which were installed just above the roller conveyors, still work reliably.
