## **RELIABLE SEAL CHECKING**

## GAP DETECTION ON CARDBOARD BOX FLAPS

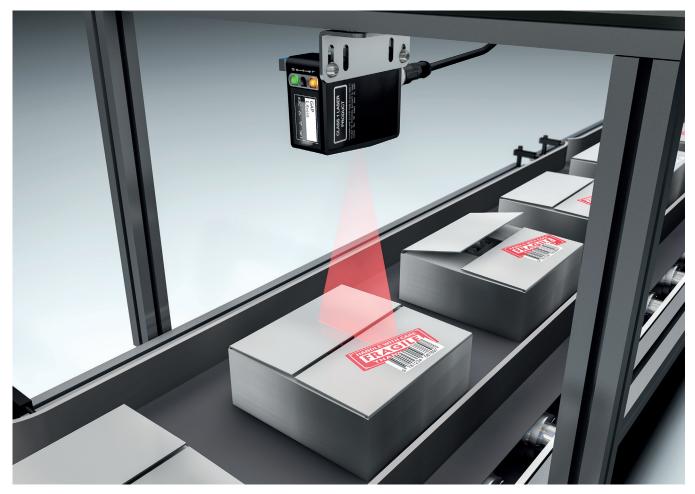
Gap detection on cardboard box flaps Image: ipf electronic

Irrespective of the box height, this sensor allows a value including tolerances to be defined for the gap between the flaps. If this value deviates from the specifications, the incorrectly sealed box is re-garded as NOK and automatically removed from the conveyor belt. The cardboard boxes can there-fore be checked using just one light section sensor which can detect the object gap reliably even if the position of individual boxes on the conveyor belt varies. This solution has many advantages compared to the previously used diffuse reflection laser sensors: simpler both with regard to configuration and signal evaluation, and also more flexible and reliable in operation.
